Roof Asset Management Program

Town of Blackstone - Municipal Office 1st Week Progress Report

Report Date: 11/01/2016

Title
1st Week Progress Report

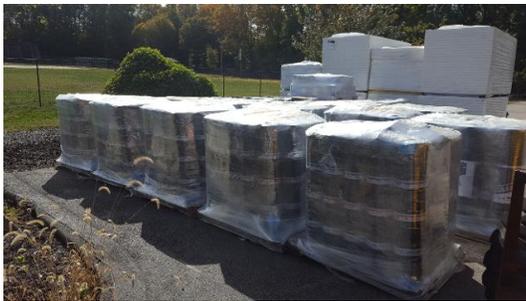
Photo 1

Oct. 13, 2016 - Materials delivered and stored in designated spot in parking lot

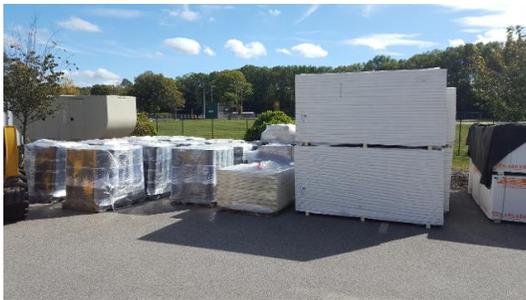
Photo 2

Oct. 13, 2016 - Materials delivered and stored in designated spot in parking lot

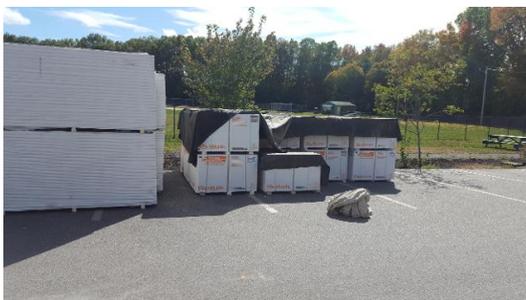
Photo 3

Oct. 13, 2016 - Materials delivered and stored in designated spot in parking lot

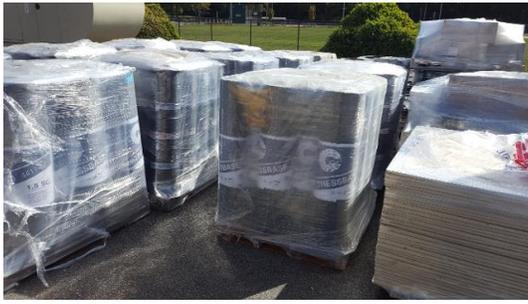
Photo 4

Oct. 13, 2016 - Materials delivered and stored in designated spot in parking lot

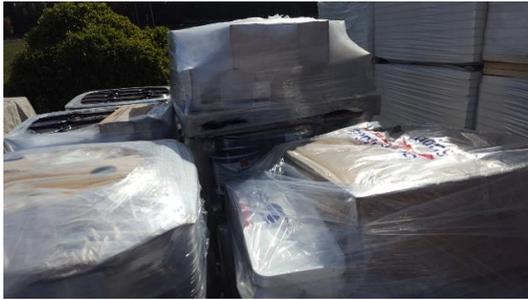
Photo 5

Oct. 13, 2016 - Materials delivered and stored in designated spot in parking lot

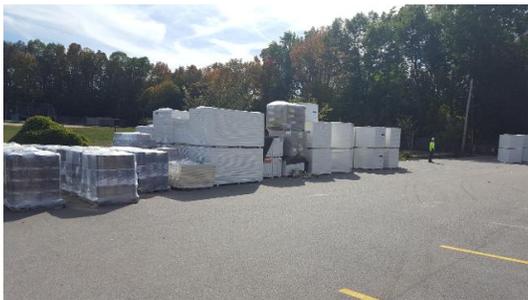
Photo 6

Oct. 13, 2016 - Materials delivered and stored in designated spot in parking lot

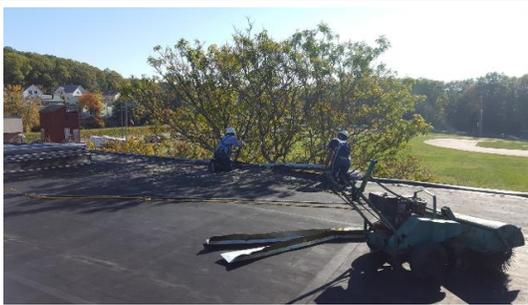
Photo 7

Oct. 17, 2016 - Existing edge metal being stripped off the roof

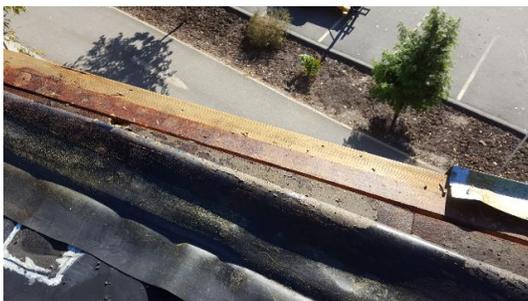
Photo 8

Oct. 17, 2016 - The existing wood nailer was inspected and found to be in very good reusable shape

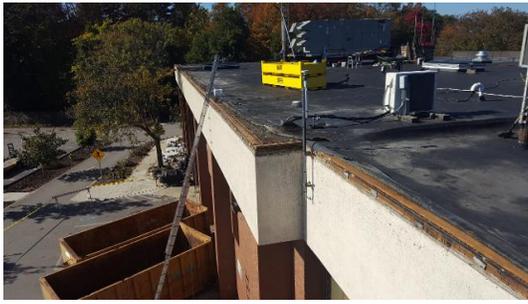
Photo 9

Oct. 17, 2016 - Back side of building existing edge metal stripped off the roof

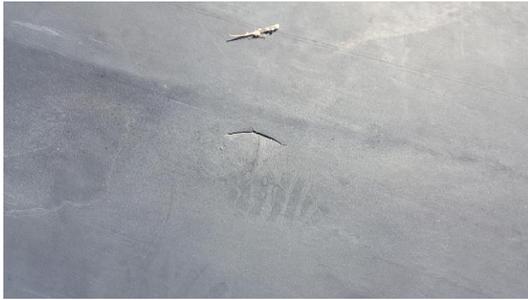
Photo 10

Oct. 17, 2016 - Cuts in the existing membrane across most of the existing roof

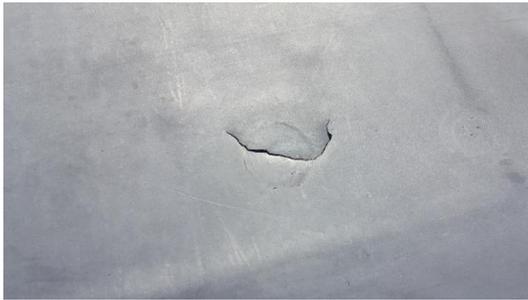
Photo 11

Oct. 17, 2016 - Cuts in the existing membrane across most of the existing roof

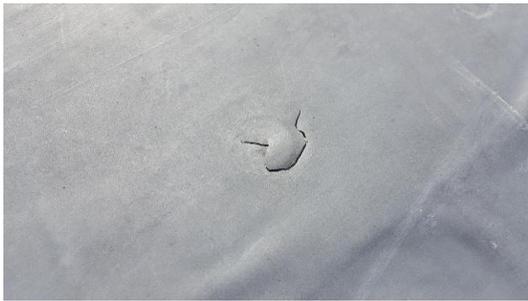
Photo 12

Oct. 17, 2016 - Cuts in the existing membrane across most of the existing roof

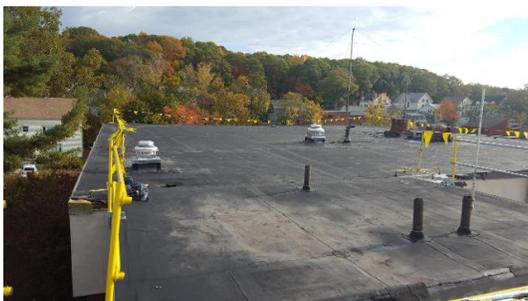
Photo 13

Oct. 19, 2016 - Safety rail and flags set up around perimeter of the roof

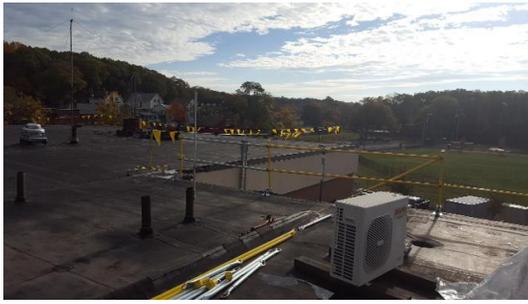
Photo 14

Oct. 19, 2016 - Safety rail and flags set up around perimeter of the roof

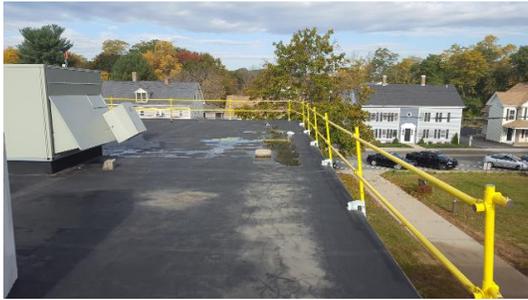
Photo 15

Oct. 19, 2016 - Safety rail and flags set up around perimeter of the roof

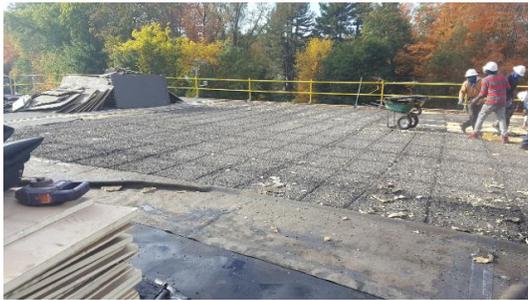
Photo 16

Oct. 19, 2016 - Existing EPDM membrane has been ripped off the roof and the original coal tar roof system being cut off the roof

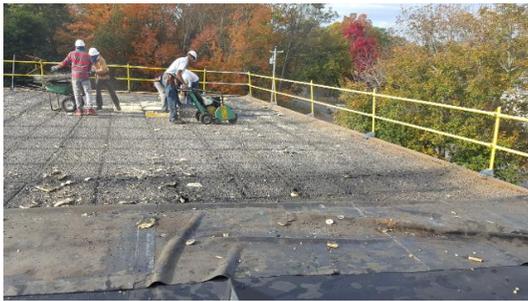
Photo 17

Oct. 19, 2016 - Existing EPDM membrane has been ripped off the roof and the original coal tar roof system being cut off the roof

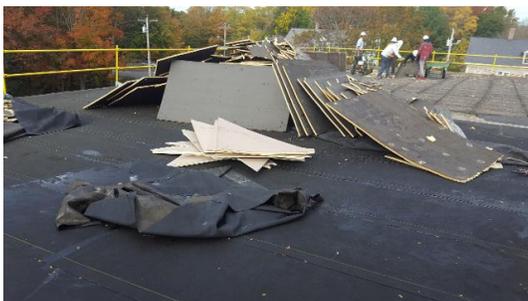
Photo 18

Oct. 19, 2016 - Existing polyisocyanurate insulation that was removed from underneath the EPDM membrane and was disposed of

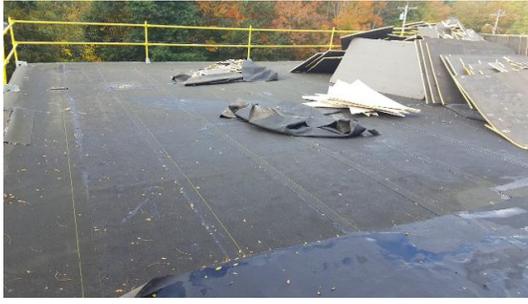
Photo 19

Oct. 19, 2016 - Starting with the drains and working towards the middle, the new tapered insulation, Secure Rock & Base Sheet is applied. This roof section was completed on Oct. 18, 2016

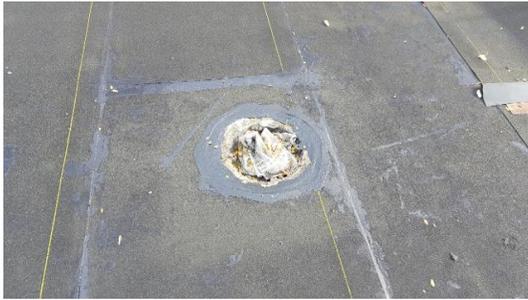
Photo 20

Oct. 19, 2016 - New insert drains were installed. Prior to install, drains were cleaned through the existing elbow to ensure proper drainage on the new roof system (drain in this picture is stuffed to ensure no new debris falls into the drain during construction). This roof section was completed on Oct. 18, 2016

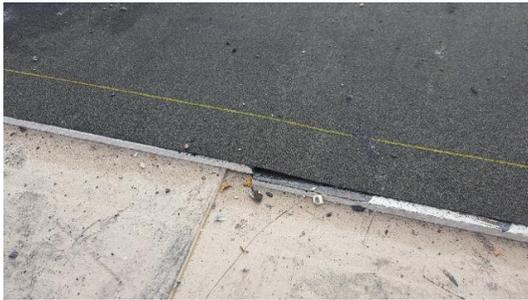
Photo 21

Oct. 19, 2016 - New base sheet set on top of new Secure Rock board

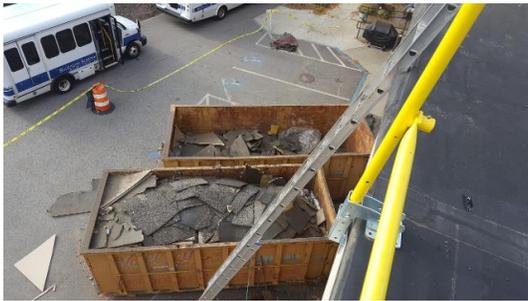
Photo 22

Oct. 19, 2016 - Existing roof systems properly disposed of in dumpsters

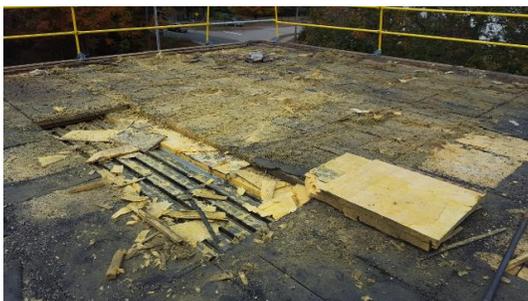
Photo 23

Oct. 19, 2016 - During tear off, the existing metal roof deck was inspected and found to be in very good condition

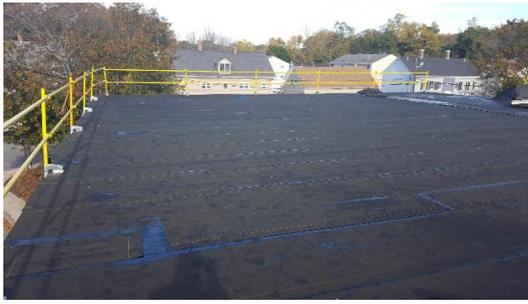
Photo 24

Oct. 20, 2016 - Second roof section base sheet installation completed

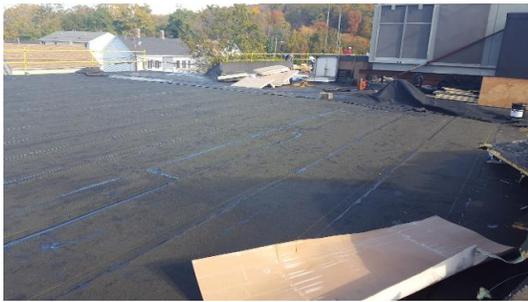
Photo 25

Oct. 20, 2016 - Second roof section base sheet installation completed

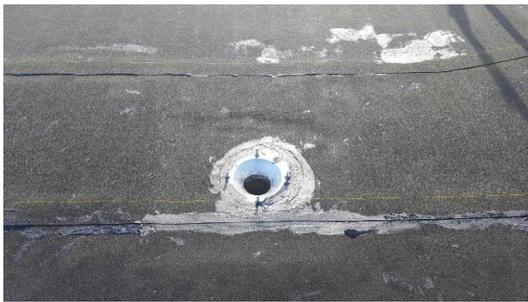
Photo 26

Oct. 20, 2016 - New drain has been set

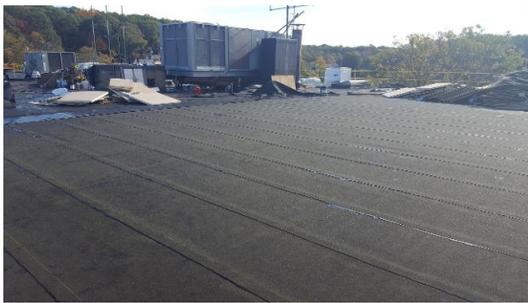
Photo 27

Oct. 20, 2016 - Second roof section base sheet installation completed

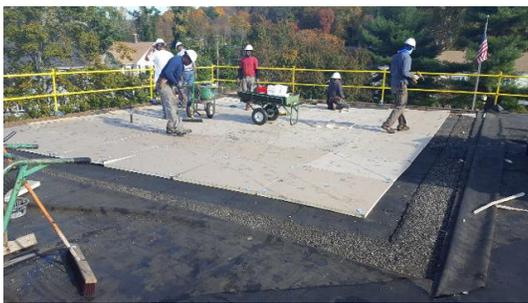
Photo 28

Oct. 20, 2016 - Third roof drain section, above municipal offices, was started and completed on this day
