Roof Asset Management Program

Town of Blackstone - Municipal Office 2nd Week Progress Report

Prepared By
Adam Silun

Report Date: 11/01/2016

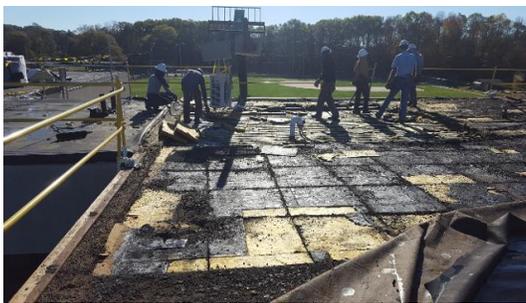
Photo 1

Oct. 24, 2016 - Existing membranes and insulation on 4th roof drain section being torn off

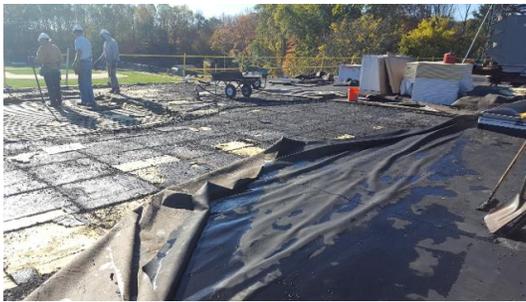
Photo 2

Oct. 24, 2016 - Existing membranes and insulation on 4th roof drain section being torn off

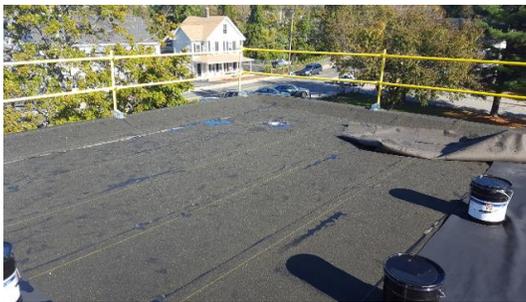
Photo 3

Oct. 24, 2016 - Completed base sheet installation on 3rd roof drain section. The newly designed tapered insulation system for roof drainage worked great in this area. Notice the minimal amount of water of the roof after we had experience 3 to 5 inches of water over the weekend

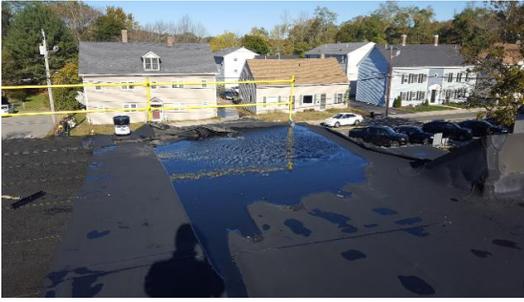
Photo 4

Oct. 24, 2016 - The roof tie-in on the completed base sheet installation on the 2nd roof drain section. A few leaks had developed due to this tie-in, which the existing EPDM membrane was used to keep the building weathertight. Unfortunately the water at this yet completed low spot overflowed in this area and was able to enter the building. The leak was due to ongoing and yet completed roof installation, the leak had nothing to do with the new base sheet installation in this area of the roof. The contractor was called during the active leak and was able to divert the water to stop the leaks in that area

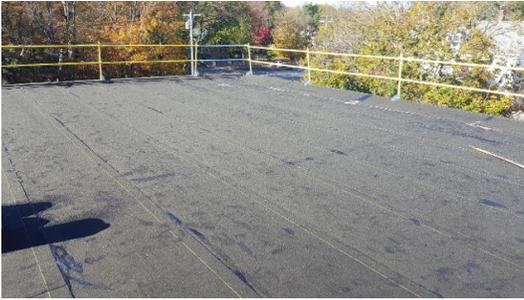
Photo 5

Oct. 24, 2016 - Completed base sheet installation on 2nd roof drain section. The newly designed tapered insulation system for roof drainage worked great in this area. Notice the minimal amount of water of the roof after we had experience 3 to 5 inches of water over the weekend

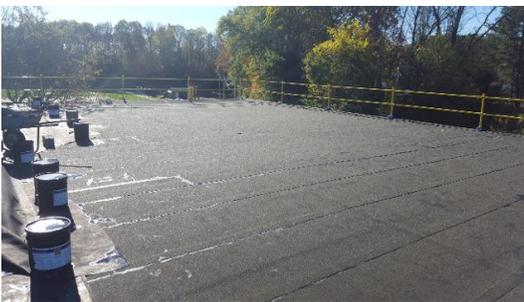
Photo 6

Oct. 24, 2016 - Completed base sheet installation on 1st roof drain section. The newly designed tapered insulation system for roof drainage worked great in this area. Notice the minimal amount of water of the roof after we had experience 3 to 5 inches of water over the weekend

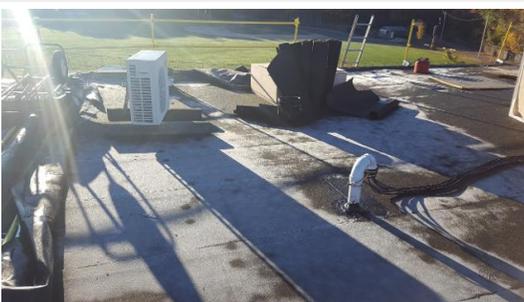
Photo 7

Oct. 25, 2016 - Completed base sheet installation on 4th roof drain section

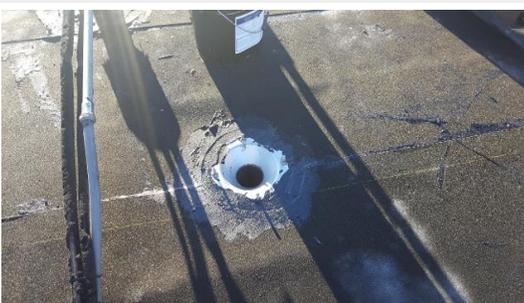
Photo 8

Oct. 25, 2016 - New drain set on 4th roof drain section

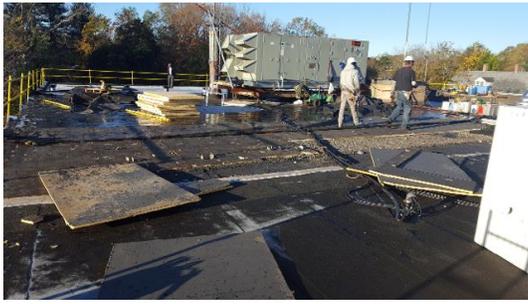
Photo 9

Oct. 25, 2016 - After the base sheet installation on all of the drain sections over the municipal offices were completed, again working from the drains out, the roof tear off of the existing membranes, etc. is started

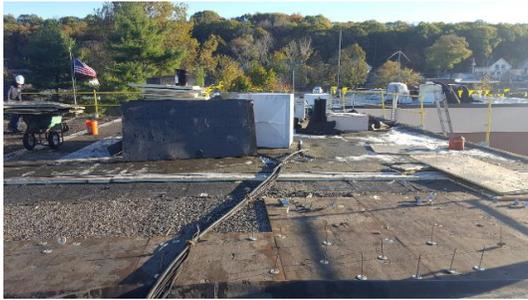
Photo 10

Oct. 25, 2016 - After the base sheet installation on all of the drain sections over the municipal offices were completed, again working from the drains out, the roof tear off of the existing membranes, etc. is started

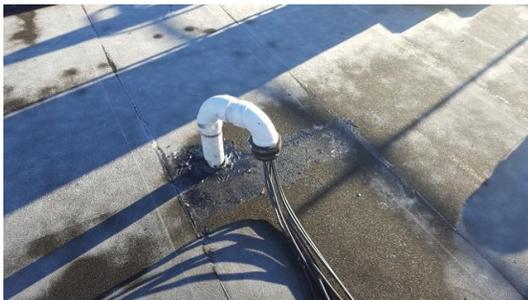
Photo 11

Oct. 25, 2016 - PVC pipe with conduit going through it had to be re-secured and foamed in place due to it being unstable after the tear off of the roof. Some debris did enter the space below due to the reworking of this pipe.

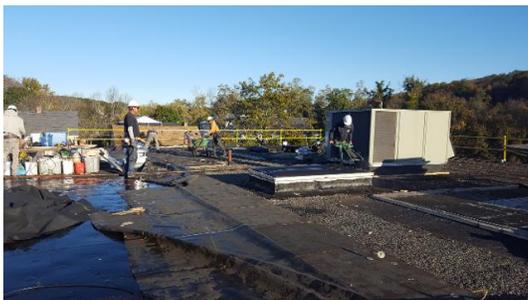
Photo 12

Oct. 25, 2016 - After the base sheet installation on all of the drain sections over the municipal offices were completed, again working from the drains out, the roof tear off of the existing membranes, etc. is started

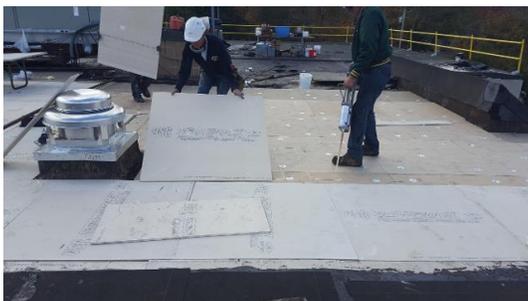
Photo 13

Oct. 26, 2016 - Secure Rock installed over newly design tapered insulation system in Garland Low Rise Foam Adhesive per the wind uplift calculations

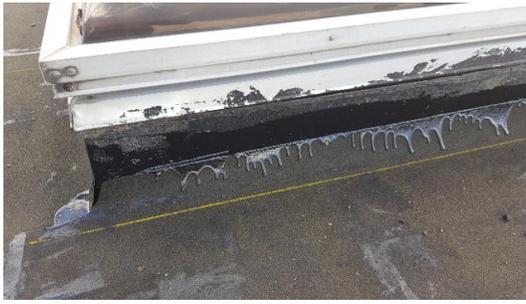
Photo 14

Oct. 26, 2016 - Base sheet installed at base of skylight. This is not the finished installation detail, picture is to detail how the base sheet is installed around roofing penetrations

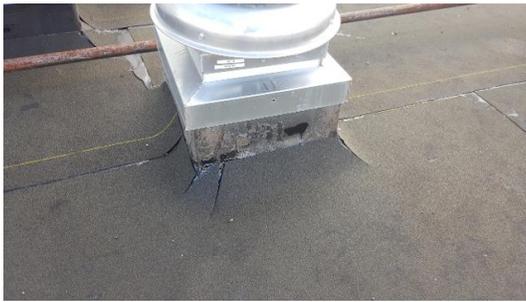
Photo 15

Oct. 26, 2016 - Base sheet installed at base of fan curb. This is not the finished installation detail, picture is to detail how the base sheet is installed around roofing penetrations

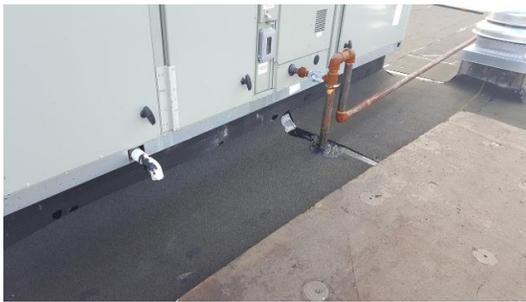
Photo 16

Oct. 26, 2016 - Base sheet installed at base of Trane Unit. This is not the finished installation detail, picture is to detail how the base sheet is installed around roofing penetrations

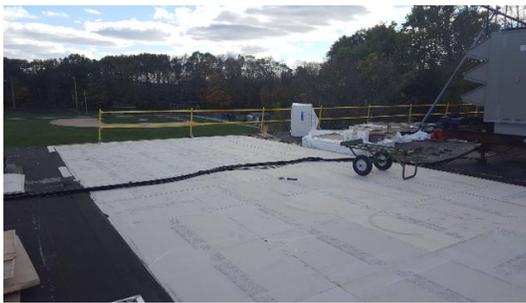
Photo 17

Oct. 26, 2016 - Installed Secure Rock

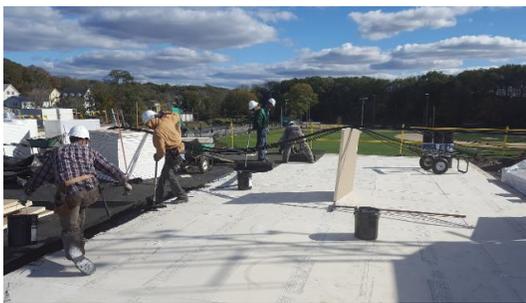
Photo 18

Oct. 26, 2016 - Base sheet being rolled out in Garland Weatherking Adhesive over new tapered insulation and Secure Rock

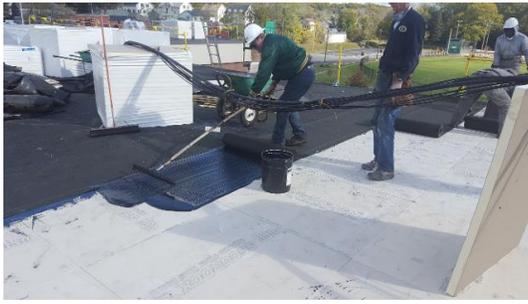
Photo 19

Oct. 26, 2016 - Base sheet being rolled out in Garland Weatherking Adhesive over new tapered insulation and Secure Rock

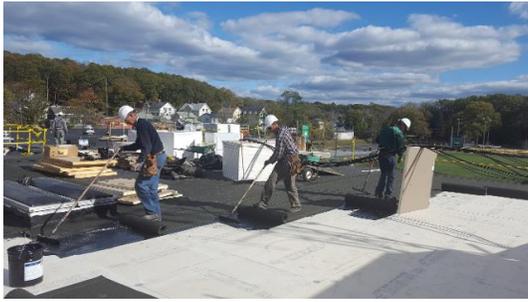
Photo 20

Oct. 26, 2016 - Base sheet being rolled out in Garland Weatherking Adhesive over new tapered insulation and Secure Rock

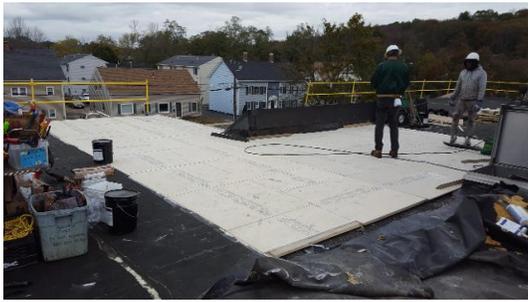
Photo 21

Oct. 27, 2016 - New tapered insulation and Secure Rock being installed on roof section next to skylights over front door to the building

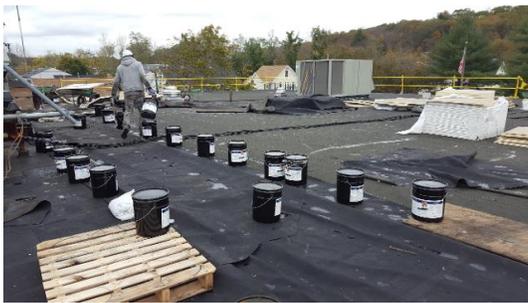
Photo 22

Oct. 27, 2016 - Previous day base sheet installation completed. Roof was tied in with existing EPDM membrane to try to ensure water tightness in the building

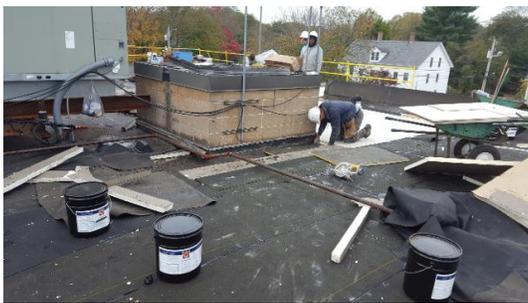
Photo 23

Oct. 27, 2016 - New base sheet being cut in around the elevator penthouse

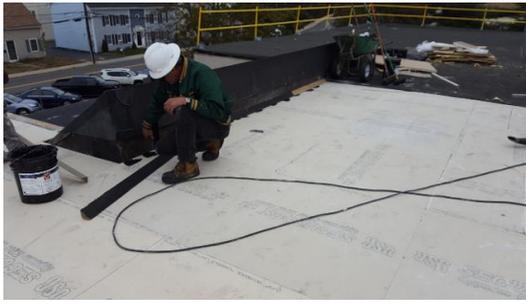
Photo 24

Oct. 27, 2016 - Cants being installed around flashing on front door skylights to make sure water is pushed away towards the slope of the roof.

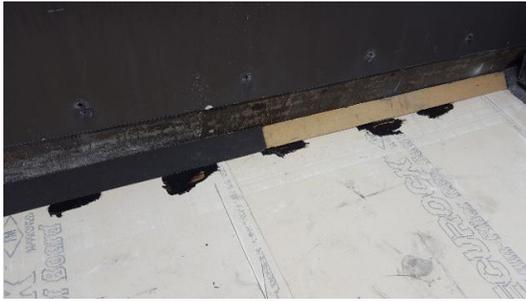
Photo 25

Oct. 27, 2016 - Cants set in adhesive

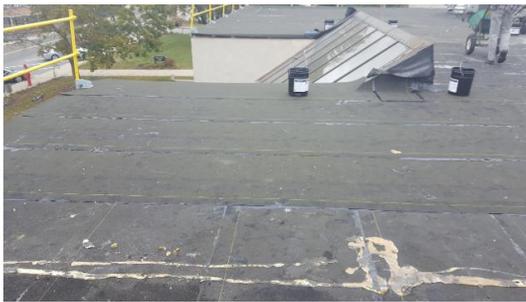
Photo 26

Oct. 27, 2016 - Base sheet installed on top roof section around skylights

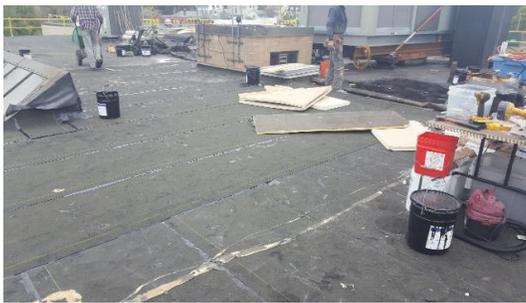
Photo 27

Oct. 27, 2016 - Base sheet installed around elevator penthouse

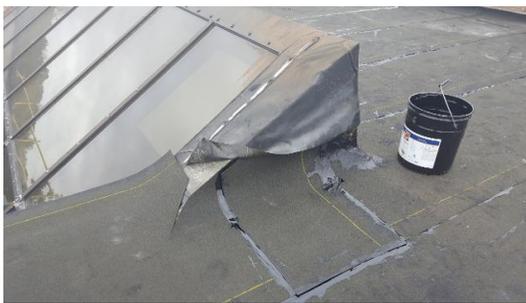
Photo 28

Oct. 27, 2016 - Base sheet installed on top roof section around skylights

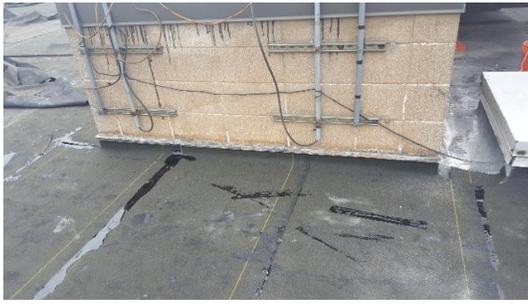
Photo 29

Oct. 27, 2016 - Base sheet installed around elevator penthouse

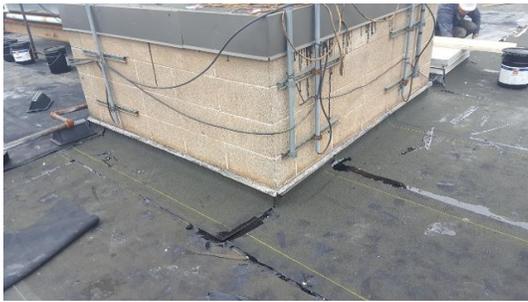
Photo 30

Oct. 27, 2016 - Base sheet installed around elevator penthouse

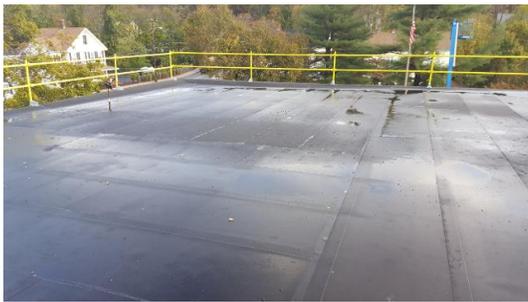
Photo 31

Oct. 28, 2016 - Roof received roughly 2 inches of the night before, notice how well the newly installed tapered insulation has allowed water to drain off of the roof

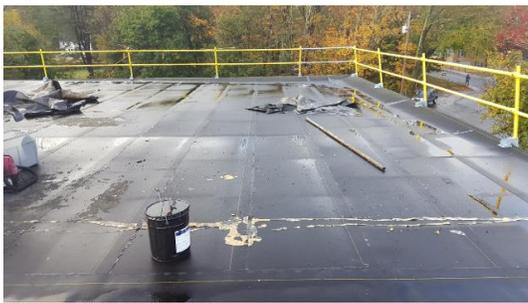
Photo 32

Oct. 28, 2016 - Roof received roughly 2 inches of the night before, notice how well the newly installed tapered insulation has allowed water to drain off of the roof

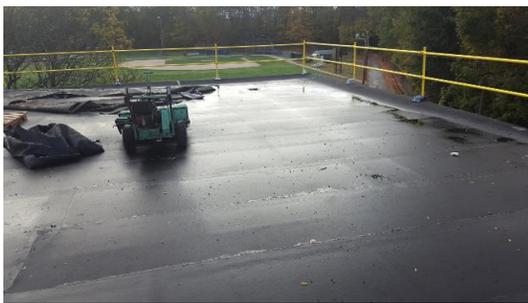
Photo 33

Oct. 28, 2016 - Roof received roughly 2 inches of the night before, notice how well the newly installed tapered insulation has allowed water to drain off of the roof

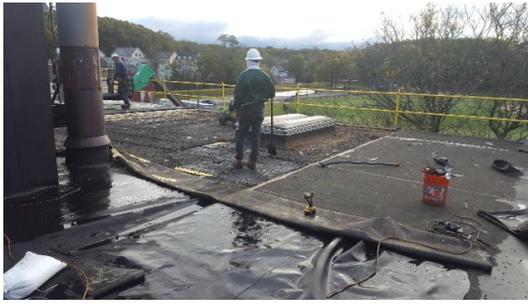
Photo 34

Oct. 28, 2016 - Next roof section tear off and replacement being started

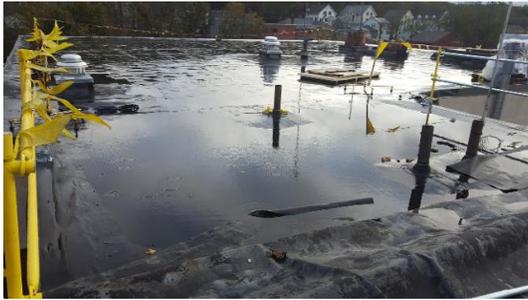
Photo 35

Oct. 28, 2016 - For reference, how the old/existing roof system drained. There is significant ponding on the Police and Fire roof section which lead to past leaks in the building

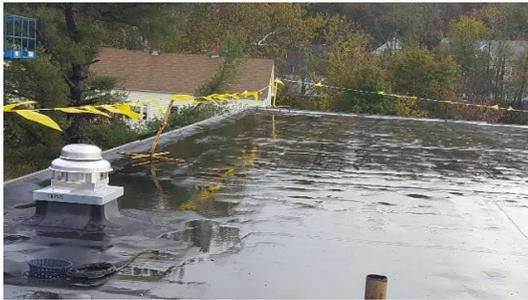
Photo 36

Oct. 28, 2016 - For reference, how the old/existing roof system drained. There is significant ponding on the Police and Fire roof section which lead to past leaks in the building
