Roof Asset Management Program

Town of Blackstone - Municipal Office 4th Week Progress Report

Report Date: 11/14/2016

Roof Section: Blackstone Town Offices

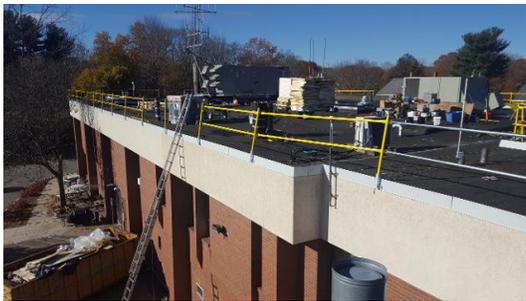
Photo 1

Nov. 7, 2016 - First piece of the two piece edge metal system is installed. The 2 coat waterproofing coating was also completed

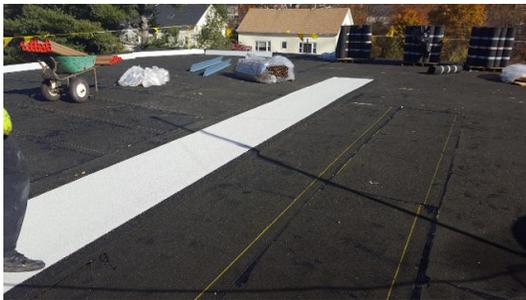
Photo 2

Nov. 7, 2016 - The cap sheet is rolled out to allow it to relax to ensure a flat installation

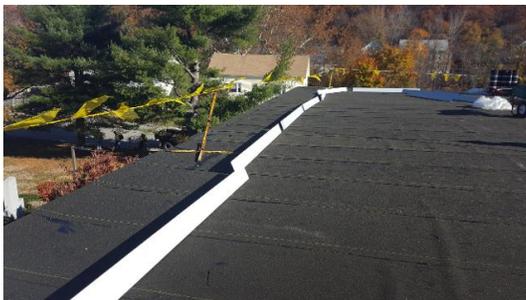
Photo 3

Nov. 7, 2016 - First piece of the two piece edge metal system was laid out

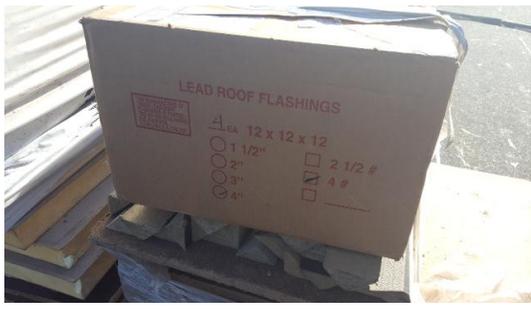
Photo 4

Nov. 7, 2016 - View of the lead roof flashing used around plumbing stacks

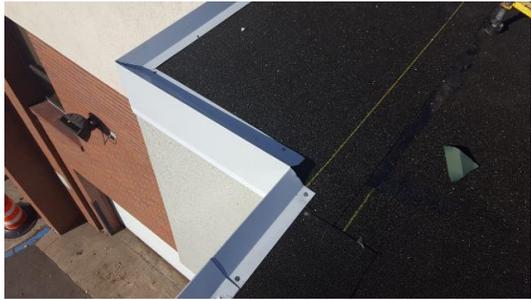
Photo 5

Nov. 7, 2016 - View of edge metal installation

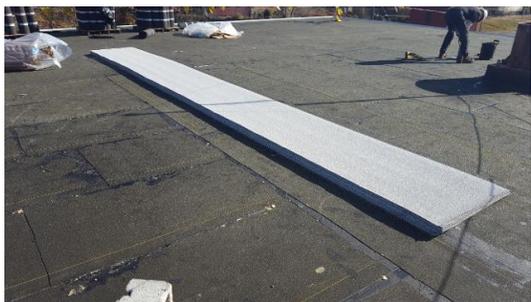
Photo 6

Nov. 7, 2016 - The cap sheet is rolled out to allow it to relax to ensure a flat installation

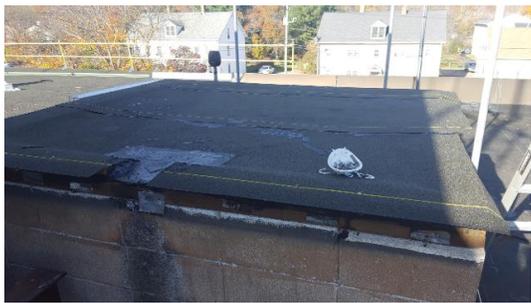
Photo 7

Nov. 7, 2016 - Base sheet installed over elevator shaft

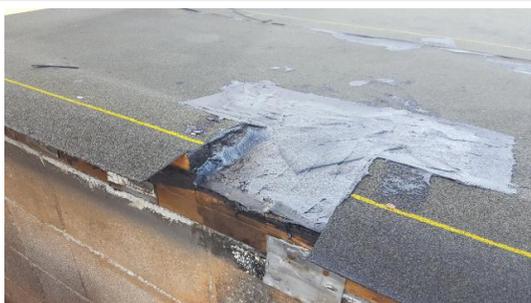
Photo 8

Nov. 7, 2016 - New spill out scupper installed over elevator shaft

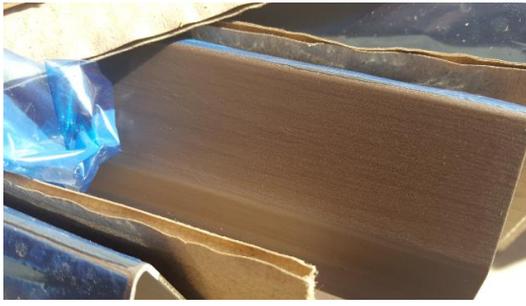
Photo 9

Nov. 7, 2016 - View of the top piece of the 2 piece edge metal system

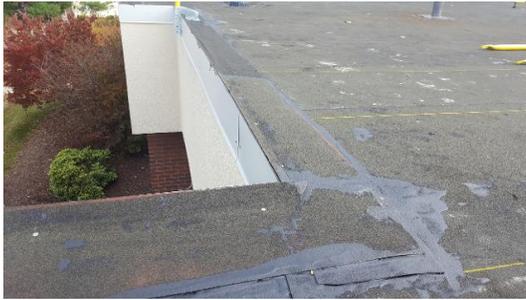
Photo 10

Nov. 9, 2016 - Flashing is installed over the first piece of the 2 piece edge metal system

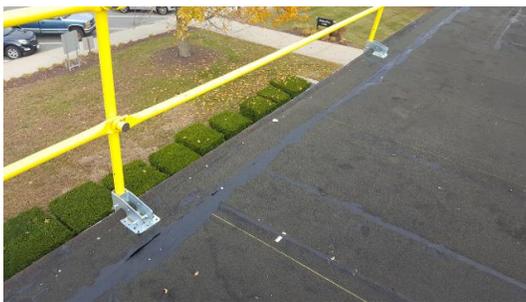
Photo 11

Nov. 9, 2016 - Alternate view of the flashing installed over the first piece of the 2 piece edge metal system

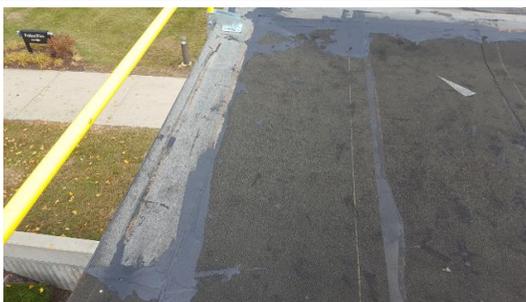
Photo 12

Nov. 9, 2016 - Alternate view of the flashing installed over the first piece of the 2 piece edge metal system

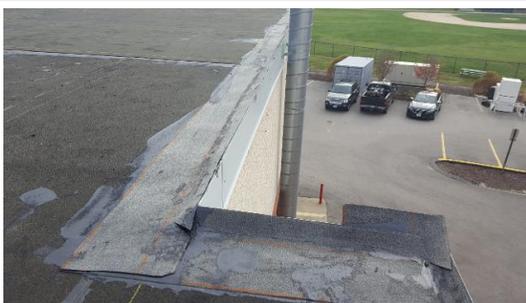
Photo 13

Nov. 9, 2016 - Alternate view of the flashing installed over the first piece of the 2 piece edge metal system

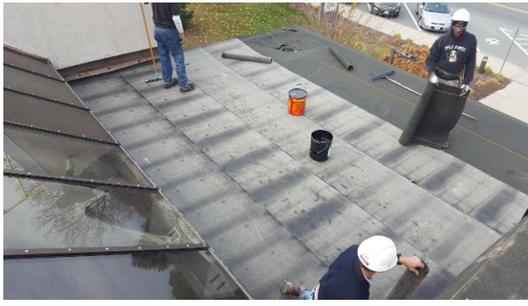
Photo 14

Nov. 9, 2016 - Base sheet being installed over the entrance vestibule roof

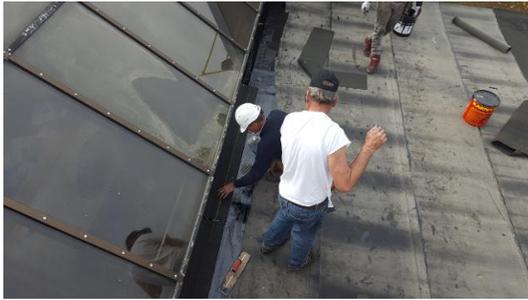
Photo 15

Nov. 9, 2016 - Base sheet being installed over the entrance vestibule roof

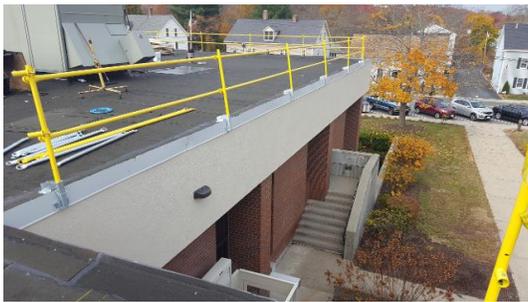
Photo 16

Nov. 9, 2016 - View of waterproofing coating with 2 coats applied

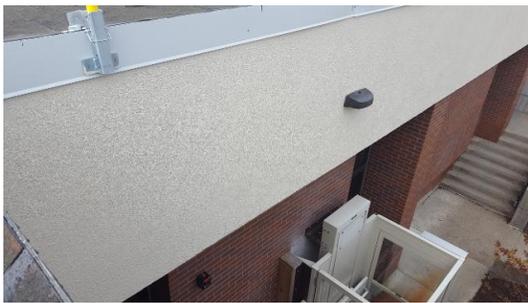
Photo 17

Nov. 9, 2016 - Alternate view of waterproofing coating with 2 coats applied

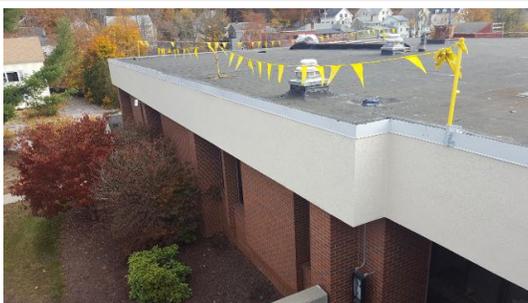
Photo 18

Nov. 9, 2016 - View of waterproofing coating with 2 coats applied

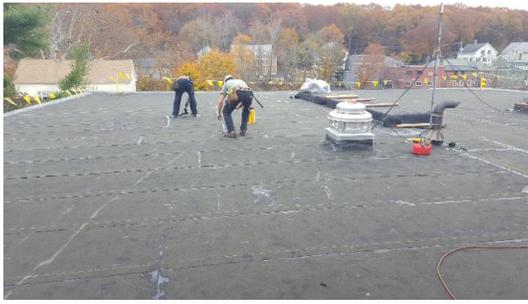
Photo 19

Nov. 9, 2016 - Mole runs being cut and repaired to prepare for cap sheet installation

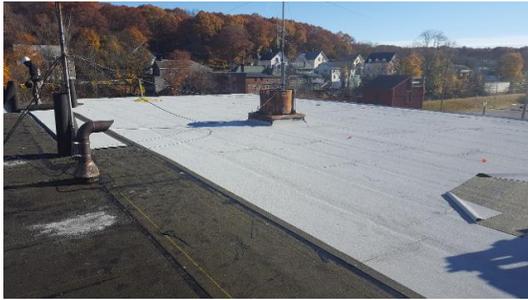
Photo 20

Nov. 10, 2016 - Cap sheet being installed over base sheet

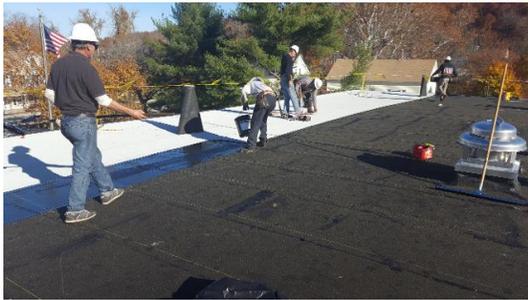
Photo 21

Nov. 10, 2016 - Cap sheet being installed over base sheet

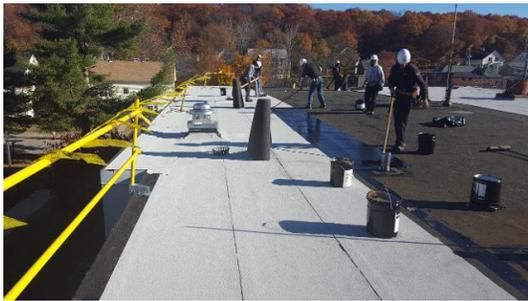
Photo 22

Nov. 10, 2016 - Cap sheet being installed over base sheet

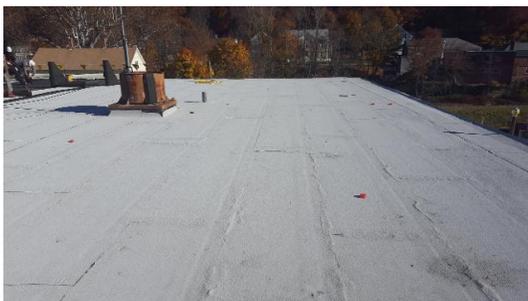
Photo 23

Nov. 10, 2016 - First half of the Police and Fire Station roof cap sheet installed

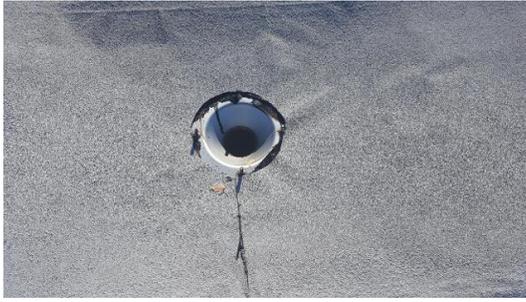
Photo 24

Nov. 10, 2016 - Roof drain flashing with cap sheet

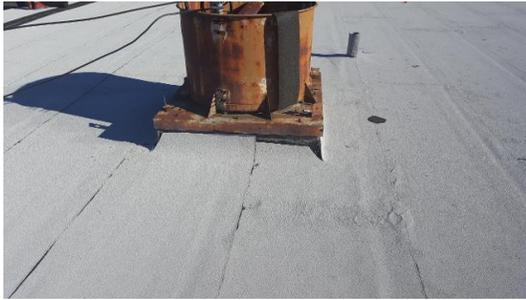
Photo 25

Nov. 10, 2016 - Existing exhaust fan over fire station roof flashing with cap sheet, this flashing detail is not complete

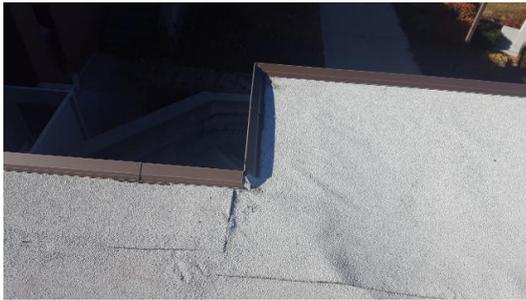
Photo 26

Nov. 14, 2016 - 2nd piece of 2 piece edge metal installed and flashed with cap sheet

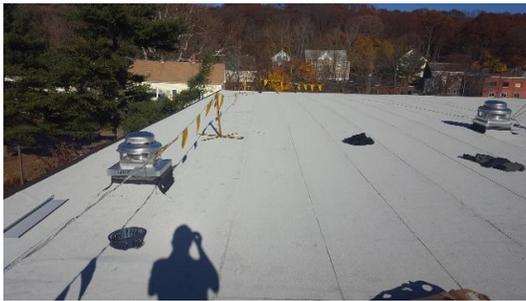
Photo 27

Nov. 14, 2016 - View of completed cap sheet installation, flashing on fans and penetrations is not complete yet

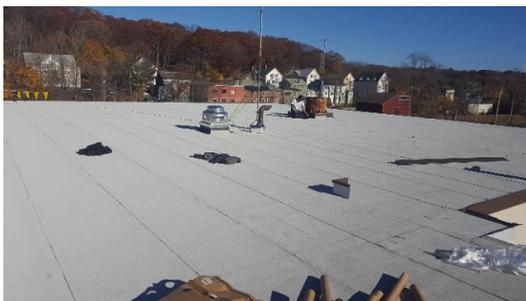
Photo 28

Nov. 14, 2016 - View of completed cap sheet installation, flashing on fans and penetrations is not complete yet

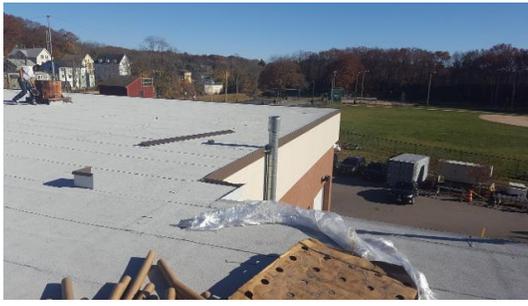
Photo 29

Nov. 14, 2016 - View of completed cap sheet installation, flashing on fans and penetrations is not complete yet

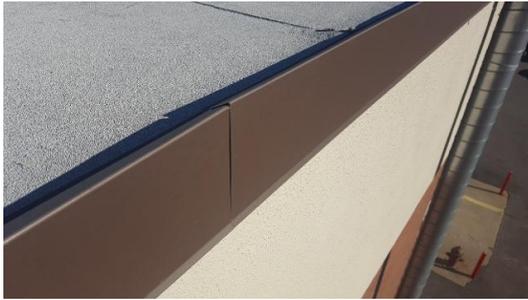
Photo 30

Nov. 14, 2016 - View of edge metal installation

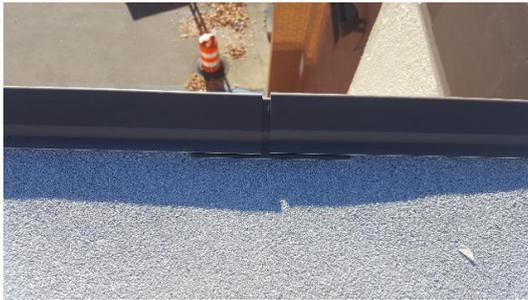
Photo 31

Nov. 14, 2016 - View of edge metal installation

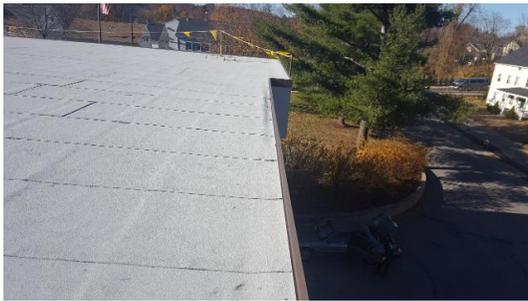
Photo 32

Nov. 14, 2016 - View of completed cap sheet and edge metal installation

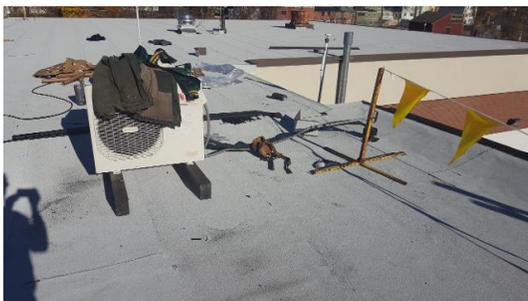
Photo 33

Nov. 14, 2016 - View of completed cap sheet and edge metal installation

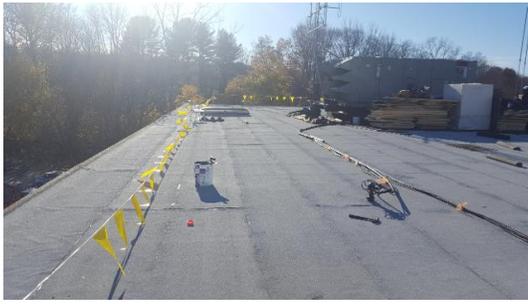
Photo 34

Nov. 14, 2016 - View of completed cap sheet and edge metal installation

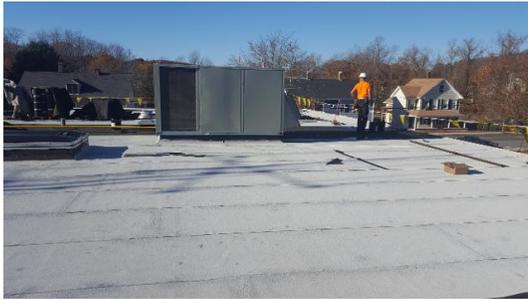
Photo 35

Nov. 14, 2016 - View of completed cap sheet installation, flashing of curbs and penetrations not yet complete

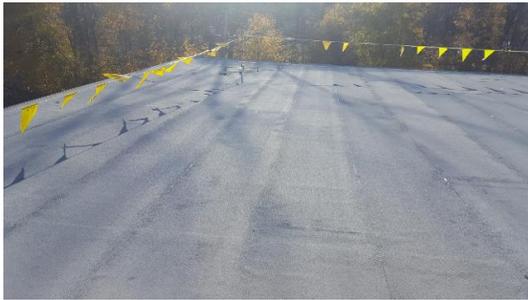
Photo 36

Nov. 14, 2016 - View of completed cap sheet installation, flashing of curbs and penetrations not yet complete

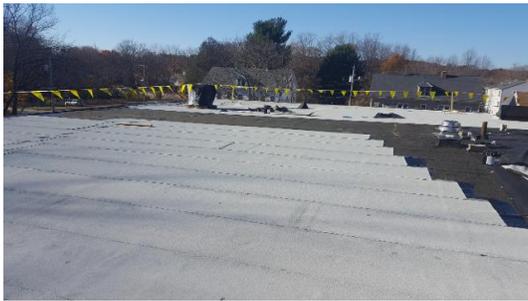
Photo 37

Nov. 14, 2016 - View of cap sheet installation in progress

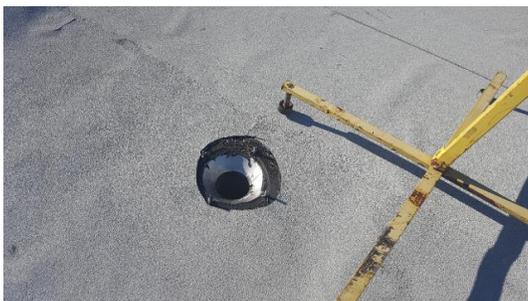
Photo 38

Nov. 14, 2016 - Roof drain flashing with cap sheet

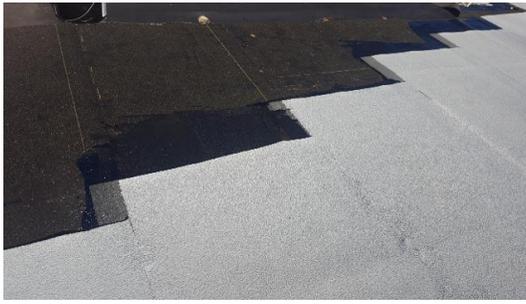
Photo 39

Nov. 14, 2016 - View of cap sheet installation in progress

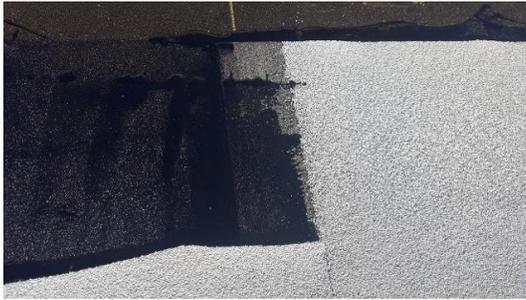
Photo 40

Nov. 14, 2016 - View of cap sheet installation in progress

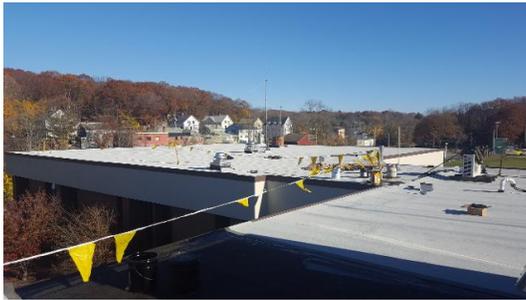
Photo 41

Nov. 14, 2016 - View of completed cap sheet, edge metal and waterproofing coating over police and fire station

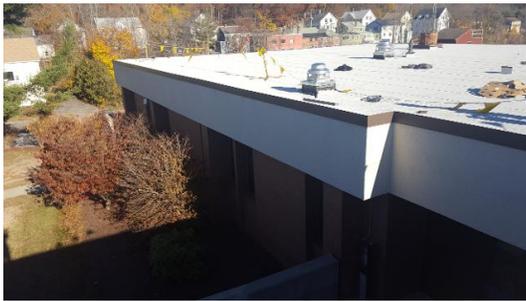
Photo 42

Nov. 14, 2016 - View of completed cap sheet, edge metal and waterproofing coating over police and fire station

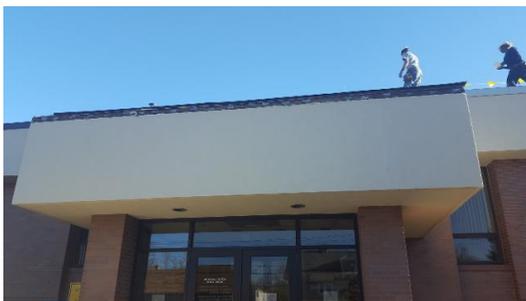
Photo 43

Nov. 14, 2016 - 2 coat waterproofing coating and repairs completed

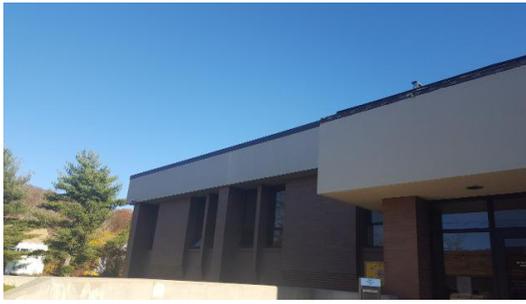
Photo 44

Nov. 14, 2016 - 2 coat waterproofing coating and repairs completed, edge metal completed in this section too

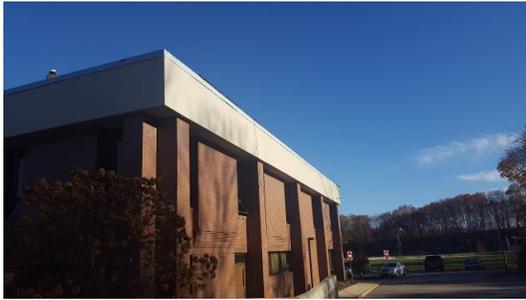
Photo 45

Nov. 14, 2016 - 2 coat waterproofing coating and repairs completed

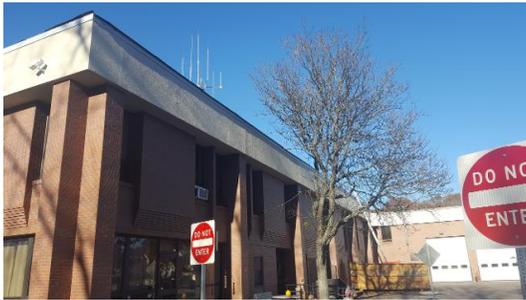
Photo 46

Nov. 14, 2016 - 2 coat waterproofing coating and repairs completed

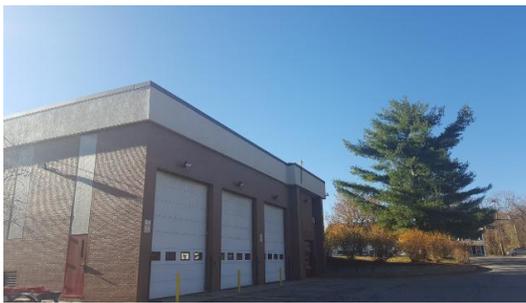
Photo 47

Nov. 14, 2016 - 2 coat waterproofing coating and repairs completed, edge metal completed in this section too

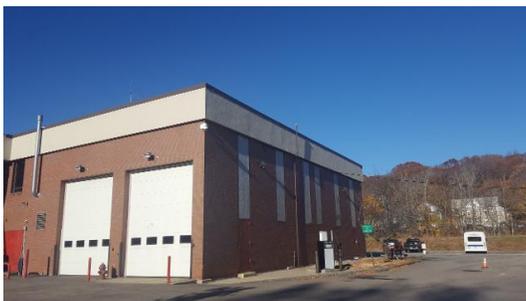
Photo 48

Nov. 14, 2016 - 2 coat waterproofing coating and repairs completed, edge metal completed in this section too

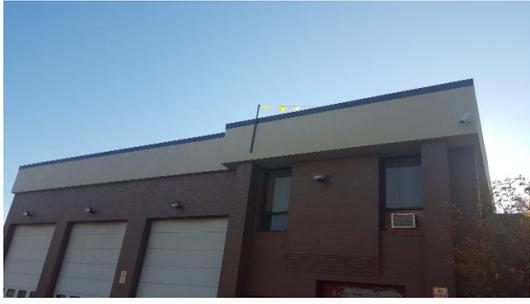
Photo 49

Nov. 14, 2016 - 2 coat waterproofing coating and repairs completed, edge metal completed in this section too
