Roof Asset Management Program

Town of Blackstone - Municipal Office 3rd Week Progress Report

Prepared By
Adam Silun

Title
3rd Week Progress Report

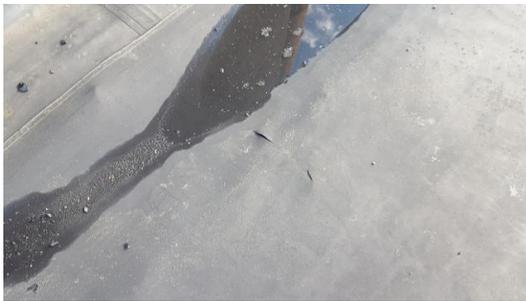
Photo 1

Oct. 31, 2016 - Over the weekend of Oct 29 & 30, we received around 2 inches of rain. The section under the main HVAC unit was tied into the new base sheet installation with the old EPDM membrane. There was a tear in the existing membrane that allowed a substantial amount of water to enter the building. The tear can be seen in this picture. Elite Roofing and Restoration has agreed to replace all damaged ceiling tiles at the completion of the project. I walked the building with Bill Walsh and took of count of all damaged ceiling tiles that need to be replaced.

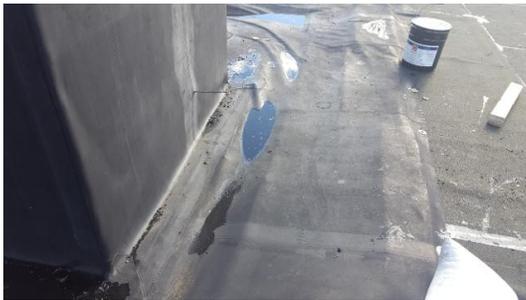
Photo 2

Oct. 31, 2016 - The small tear that allowed water to enter the building was located right in front of the small puddle in front of the duct work.

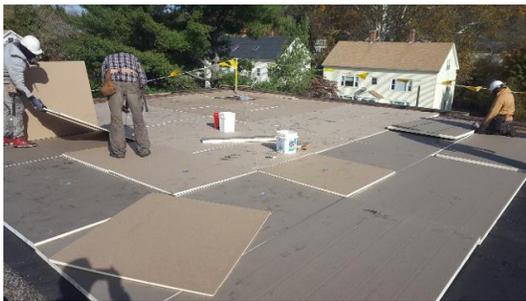
Photo 3

Oct. 31, 2016 - Tapered insulation leading to the drain is being put down

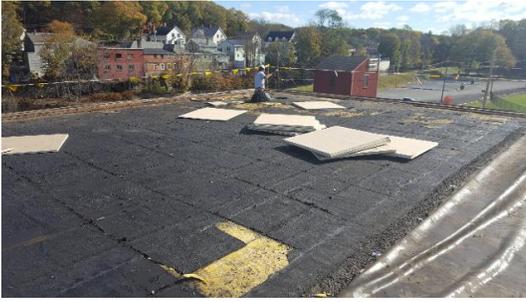
Photo 4

Oct. 31, 2016 - The existing roof system was removed and the existing fiberglass insulation is seen in this picture.

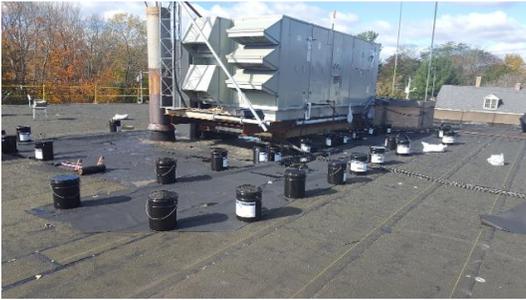
Photo 5

Oct. 31, 2016 - View of how the middle of the roof was tied into the newly installed base sheet. This tie is temporary and allows deter any water from entering the building during the phased installation of the new roof system.

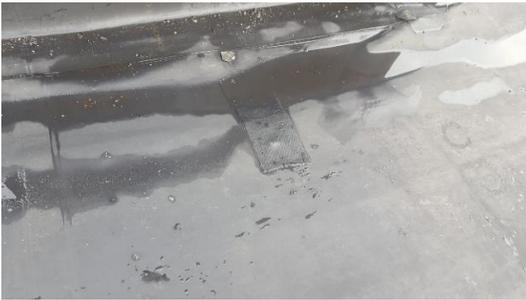
Photo 6

Oct. 31, 2016 - The tear in the membrane was patched and no water has entered via the tie in (or at any point) on the new roof system

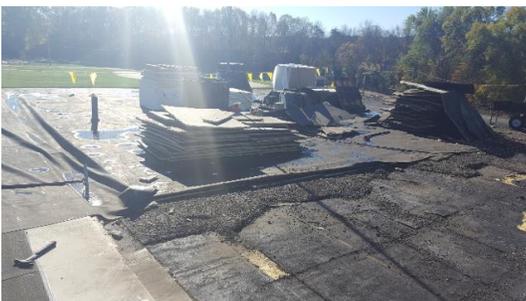
Photo 8

Nov. 1, 2016 - The old roof system(s) over the Police and Fire Stations being removed

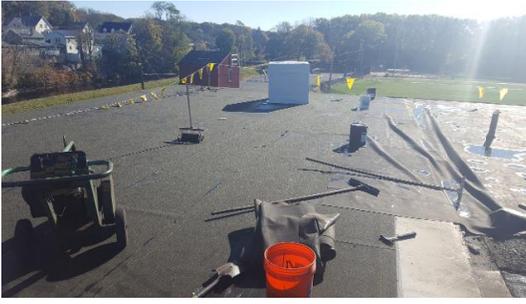
Photo 9

Nov. 1, 2016 - The new base sheet being installed over the Police and Fire Station

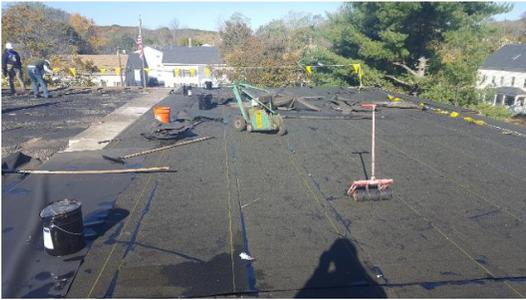
Photo 10

Nov. 1, 2016 - Alternate view of the new base sheet being installed over the Police and Fire Station

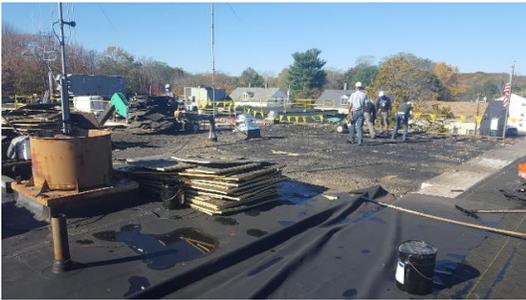
Photo 11

Nov. 1, 2016 - The old roof system coming off and being prepared for the new tapered insulation system

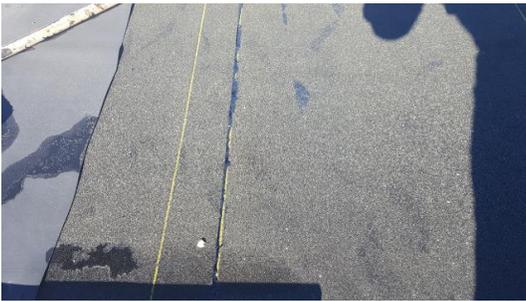
Photo 12

Nov. 1, 2016 - Each base sheet is lapped over the adjacent sheet a minimum of 6" (yellow line is the indicator). Notice the bleed out of membrane adhesive, this shows there is a proper amount of adhesive being used.

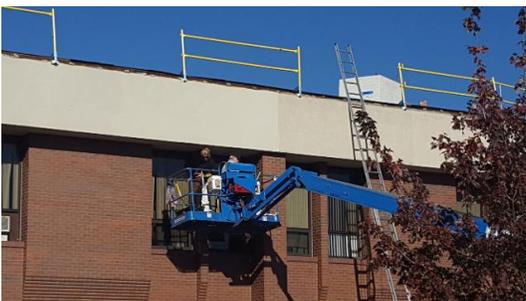
Photo 13

Nov. 1, 2016 - The EIFS system around the building was repaired and the first coat of waterproofing coating is applied. The holes in the EIFS were mostly due to the presence of bugs inside the EIFS and birds, mostly woodpeckers, had pecked holes in the EIFS to get at the bugs. All of those holes and cracks were sealed with non-shrink sealant and/or foam

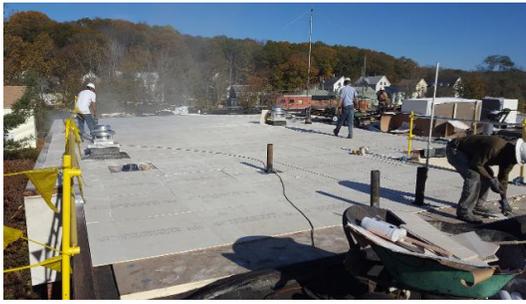
Photo 14

Nov. 1, 2016 - The new tapered insulation system was installed and the Secure Rock cover board is put down over the newly installed insulation

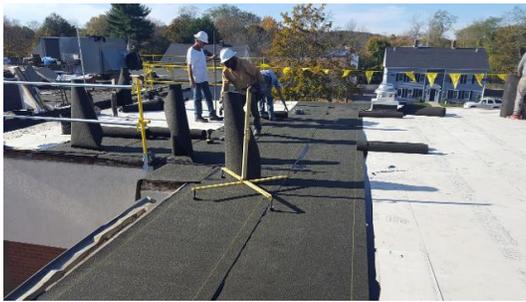
Photo 15

Nov. 1, 2016 - New base sheet being installed over newly installed tapered insulation

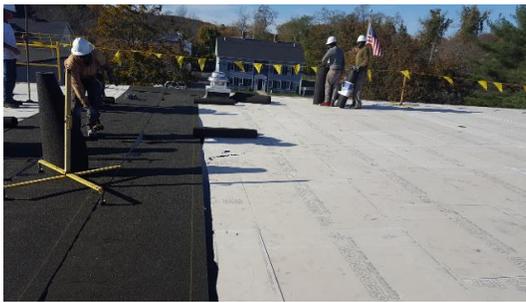
Photo 16

Nov. 1, 2016 - Alternate view of the new base sheet being installed over the Police and Fire Station

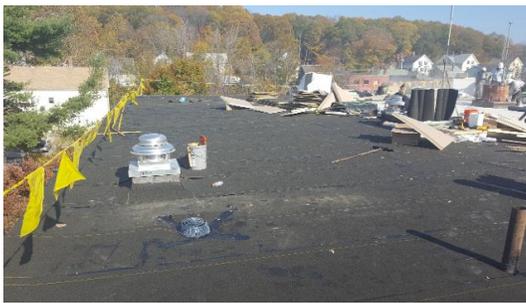
Photo 17

Nov. 2, 2016 - The new base sheet installed over the Police and Fire Station

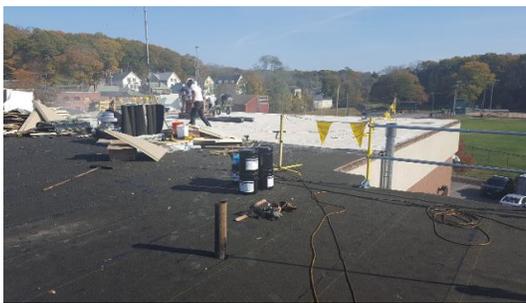
Photo 18

Nov. 2, 2016 - The new base sheet installed over the Police and Fire Station with the next section of the roof being prepared for the new base sheet. Again, new tapered insulation is installed and Secure Rock cover board is put down

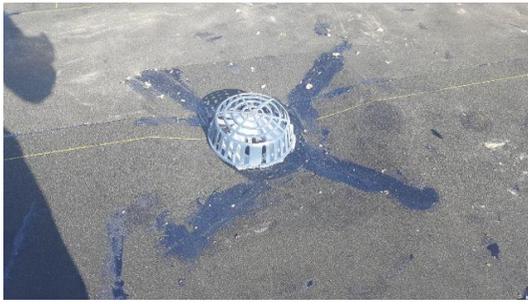
Photo 19

Nov. 2, 2016 - New drain installed with a 4'x4' sump to promote even better drainage, in addition to the tapered insulation system. This picture shows the base sheet flashing the drain, this is not the finished installation.

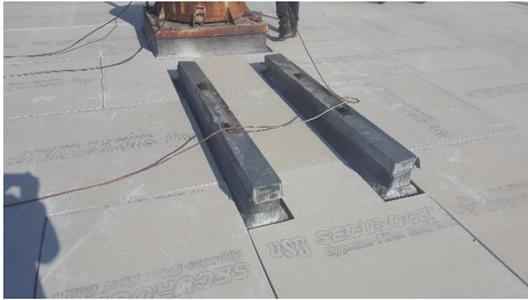
Photo 20

Nov. 2, 2016 - The old, inoperable fan was removed from the roof and the old sleepers supporting the fan was also removed

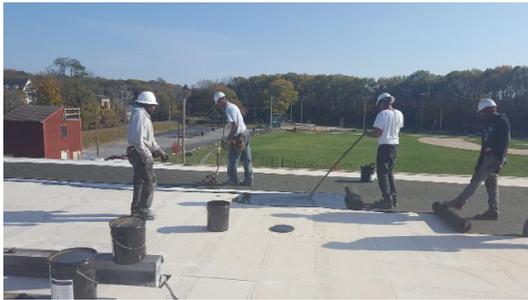
Photo 21

Nov. 2, 2016 - The new base sheet being installed over the Police and Fire Station, the new base sheet is rolled with a weighted roller to ensure full contact with the membrane adhesive

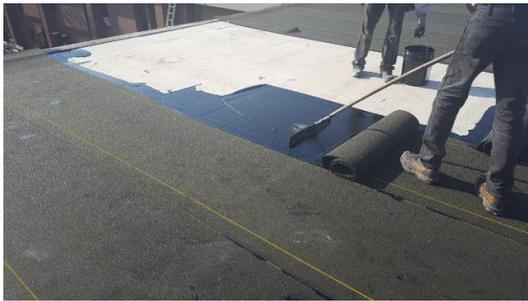
Photo 22

Nov. 2, 2016 - View of base sheet overlap and application of adhesive with a squeegee

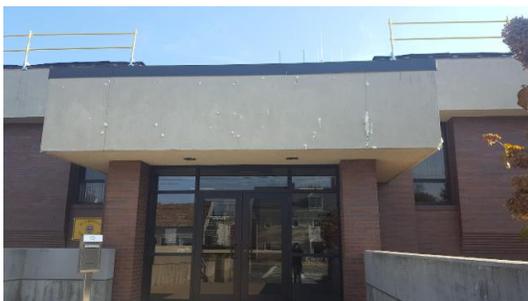
Photo 23

Nov. 2, 2016 - Foam was using to fill in the large holes in the EIFS caused by birds

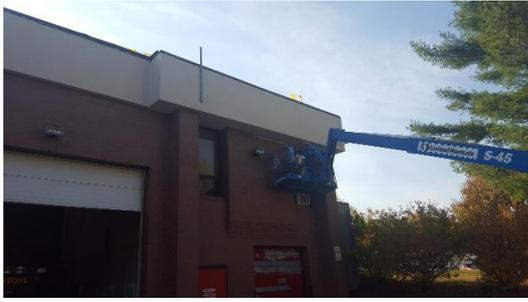
Photo 24

Nov. 2, 2016 - Waterproofing coating being applied

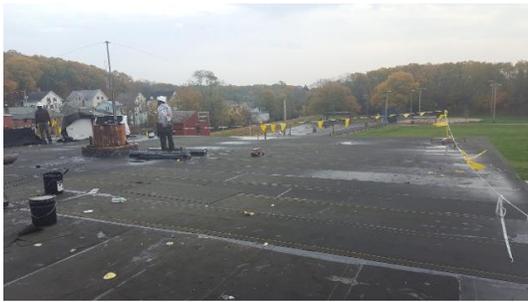
Photo 25

Nov. 3, 2016 - The new base sheet installed over the Police and Fire Station

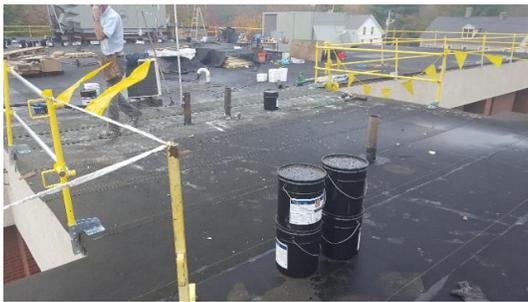
Photo 26

Nov. 3, 2016 - The new base sheet installed over the Police and Fire Station

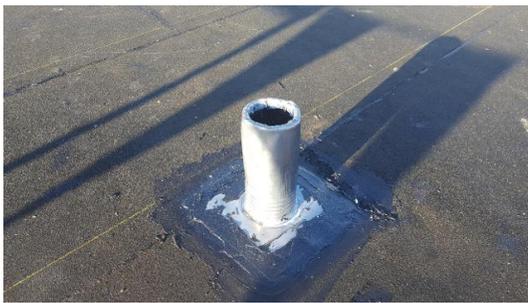
Photo 27

Nov. 3, 2016 - The drain stacks were leaded and flashed, this is not the final installation

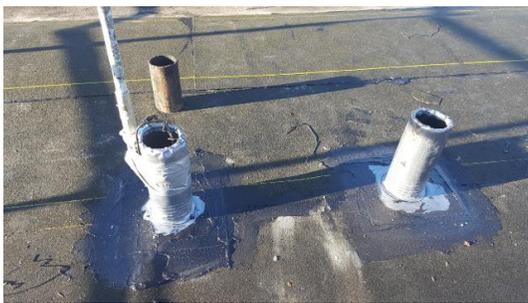
Photo 28

Nov. 3, 2016 - The drain stacks were leaded and flashed

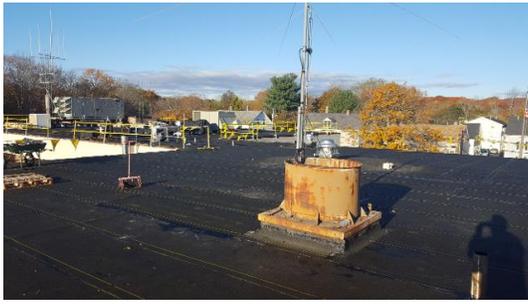
Photo 29

Nov. 3, 2016 - Completed base sheet installation over the Police and Fire Station

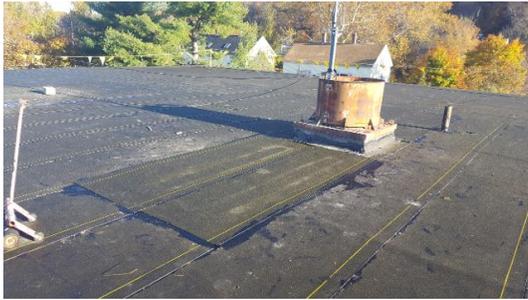
Photo 30

Nov. 3, 2016 - The old fan supports were removed for a cleaner installation

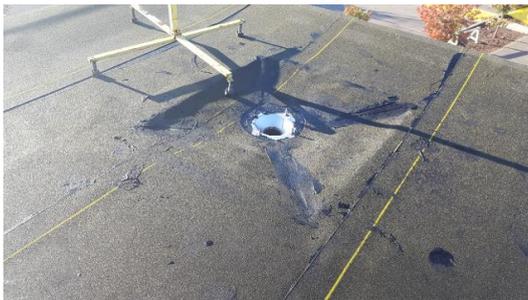
Photo 31

Nov. 3, 2016 - Drain flashed with base sheet and with a 4'x4' around the drain to promote better drainage

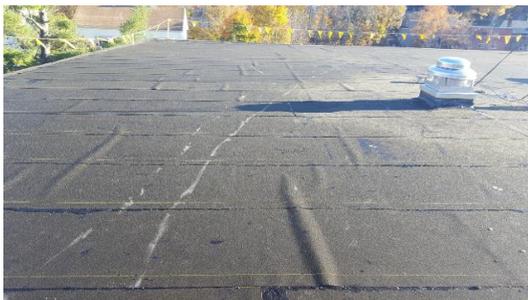
Photo 32

Nov. 4, 2016 - Mole runs had formed in some sections of the base sheet. This is from the base sheet expanding a bit from the sun. All mole runs were cut and patched to ensure a clean installation and to prepare the base sheet for the cap sheet installation
